The Threat to Portsmouth Harbour

Christopher Donnithorne

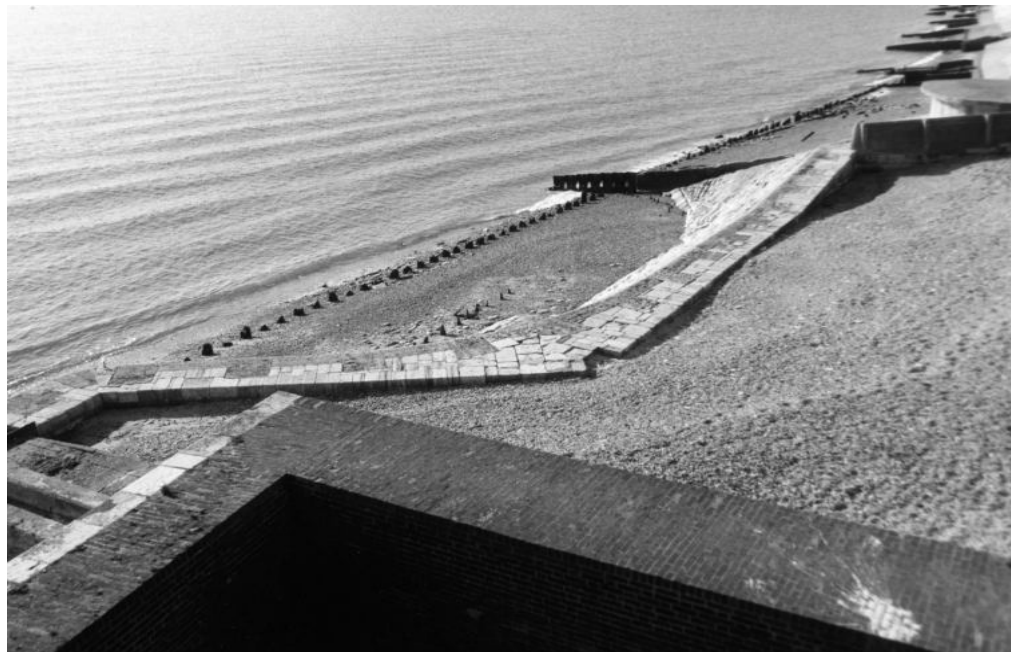
Figure 25 1987 Remains of the piles - see fig. 24 above. MoD.

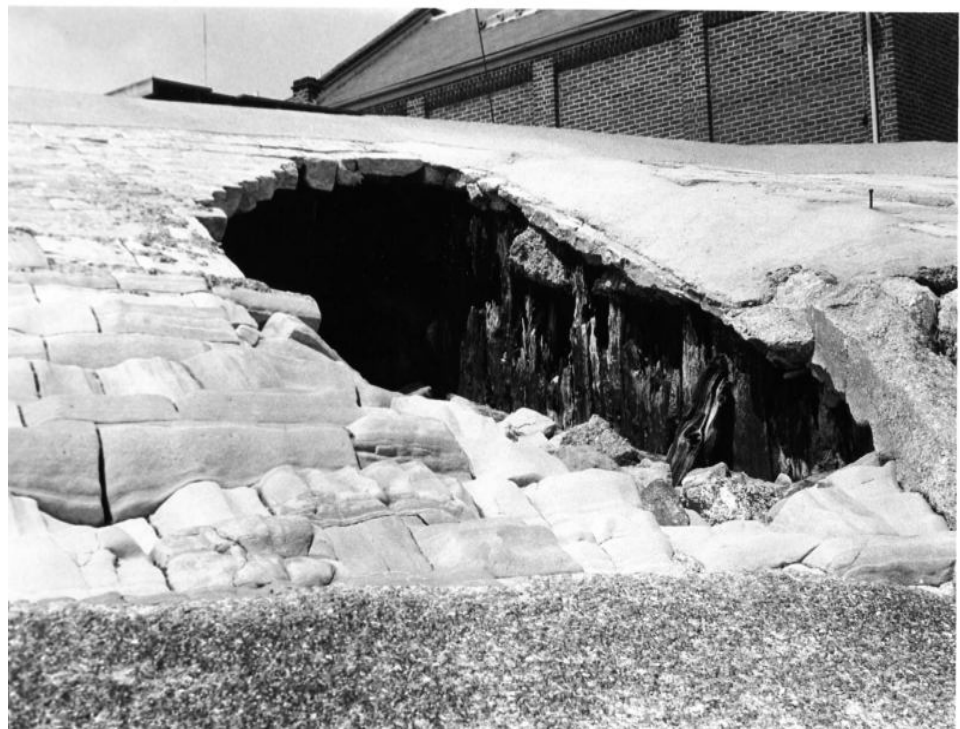
The hole in fig. 27 illustrates the construction method. A wooden framework, in-filled with marl - usually a combination of clay and flint - then tamped and capped with a stone facing. Wear on the stone is inevitable. All remains well until inadequate maintenance allows waves to penetrate through the wall itself where, over time, a void is hollowed out.

Figure 27 The hole on the wall in 1986. MoD.

Given the appropriate storm conditions, sea is able to flood from the bottom at the same time as waves penetrate from the top. Trapped air is compressed and expands explosively as the wave passes - hence few stones remaining in the hole. This cause was identified in 1986 and ignored.

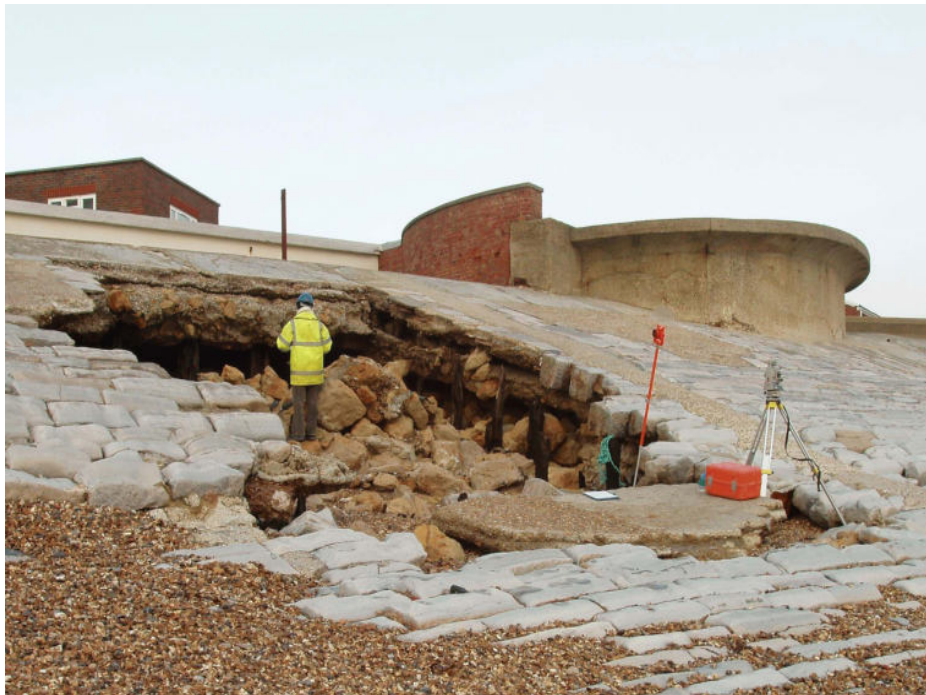
The next major hole appeared in 2006 in almost the same spot which does not say a huge amount for the quality of the first repair. Note a totally different form of collapse due to the altered construction after the repair.

Figure 28 2006. The hole in the wall, in almost the same spot. Note the WW11 construction to the right; [source unidentified].

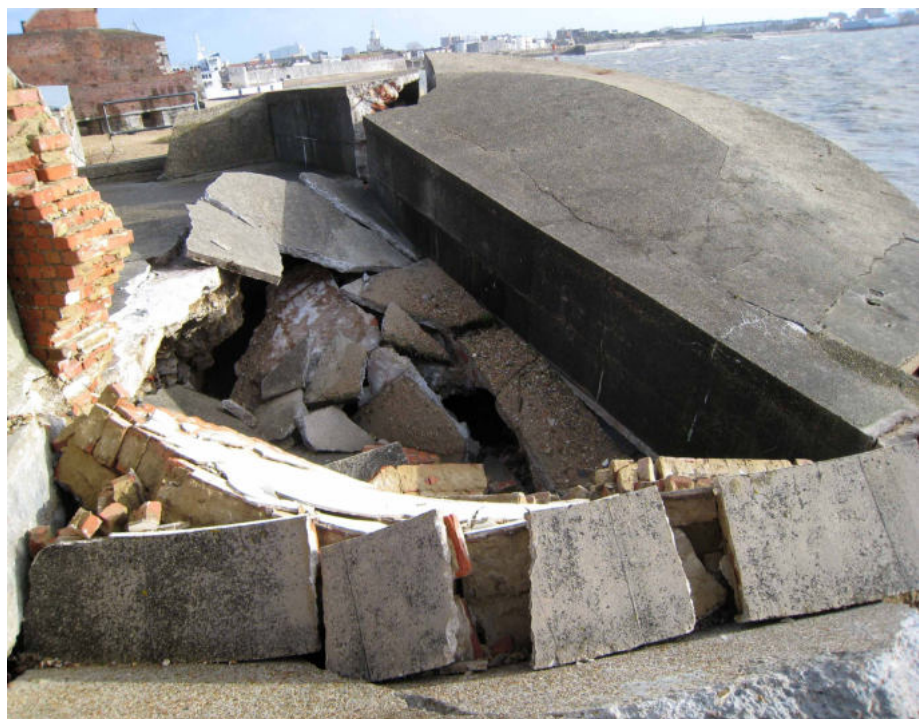
Figure 29 Just to the right of the 2006 hole, the WW11 structure [Fig. 28 above] has been demolished. CHD.

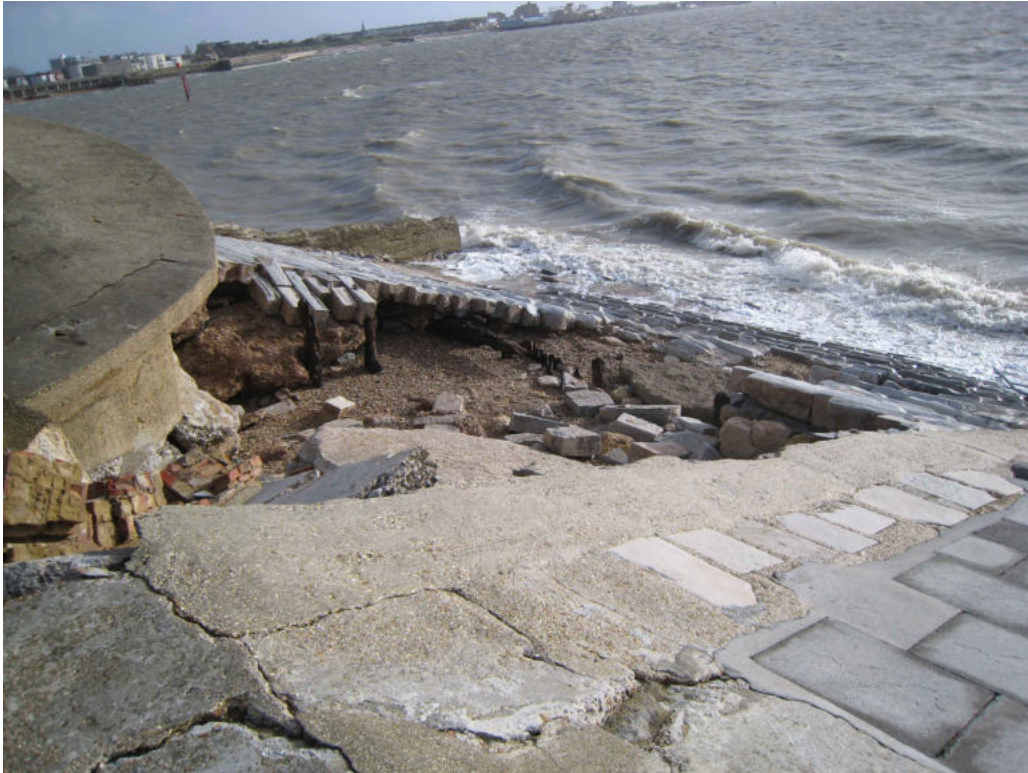
Figure 30 6 Jan 2014. The explosive nature of the event is self-evident; most of the stone facings have been blown clean out of the hole. CHD.

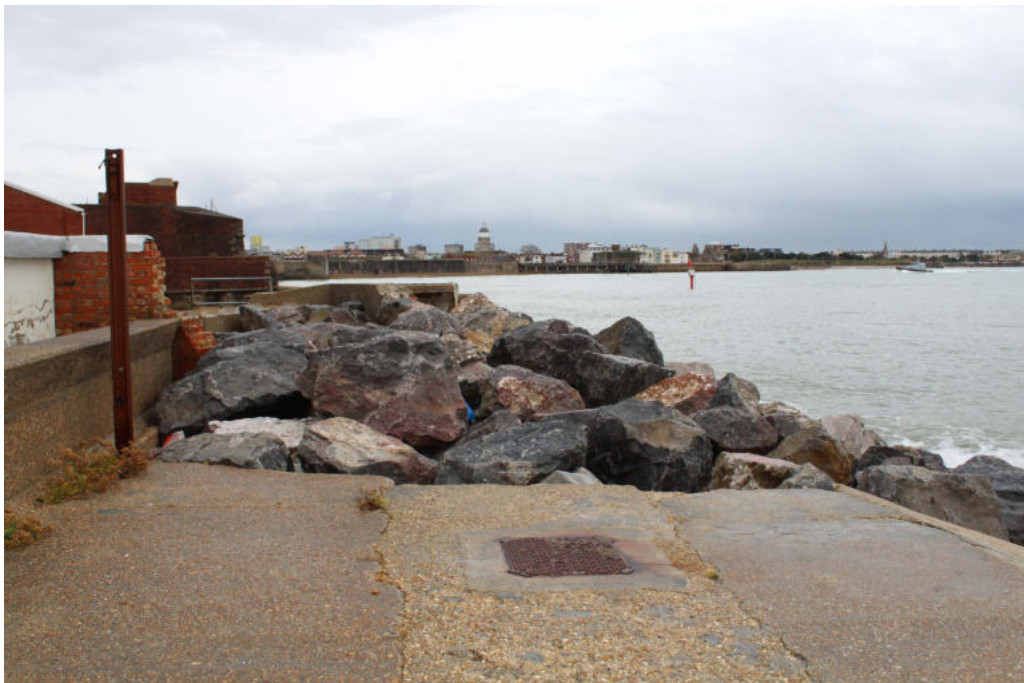
Figure 31 14 Jan 2014. The repair looks suitably impressive but, in practice, probably served to expedite the erosion process. CHD.

Remedial action was taken very promptly, even for an emergency temporary repair. Six years later, it seems that any thought of a permanent repair had long since been conveniently forgotten. Storms in 2020 exposed the wall again and tossed out much of the rock armour.

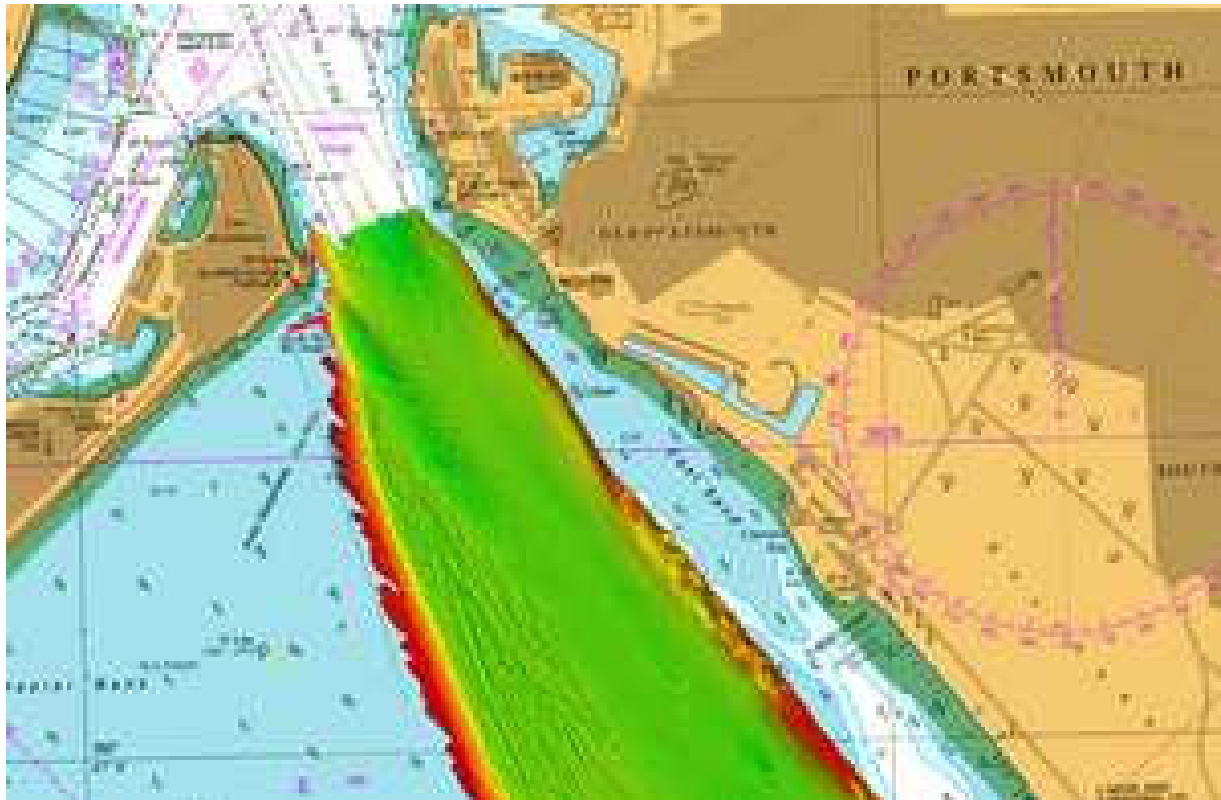
Figure 36 Bathymetric Data for Portsmouth approaches gathered by HMS *Gleaner*, showing the actual profile, post-dredge. Hamilton Bank is immediately to the south of the Fort, to the right of Haslar Bank; the red colour represents near vertical sides; UK Hydrographic Office, published Aug 2017 [i.e. post-dredge]. © UKHO.

The result of the carrier dredge provided a wider and deeper channel than ever before, with near vertical sides, in a material largely composed of sand and shingle. It was inevitable and entirely predictable that the sides would be unstable, the rate of any ‘slippage’ being dependant to a great extent on weather conditions. Likewise it was expected that the greatest erosion would be from the Hamilton Bank due to the combined effect of prevailing weather patterns and littoral drift. It would be wonderful to be proved wrong but all the evidence suggests that the partial collapse of Hamilton Bank is progressive.

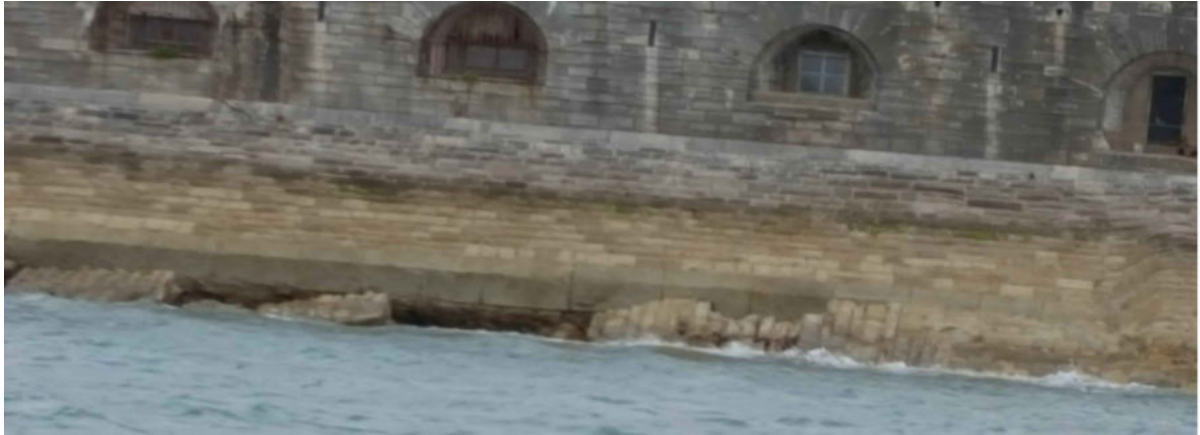
In 2019, damage became apparent in front of the main battery at Blockhouse, and the alarm was raised. This damage put the fort itself at risk since a partial collapse would have an immense impact on the harbour.

Figure 37 6 Aug 2019. Damage to sea wall in front of Blockhouse main battery. CHD.

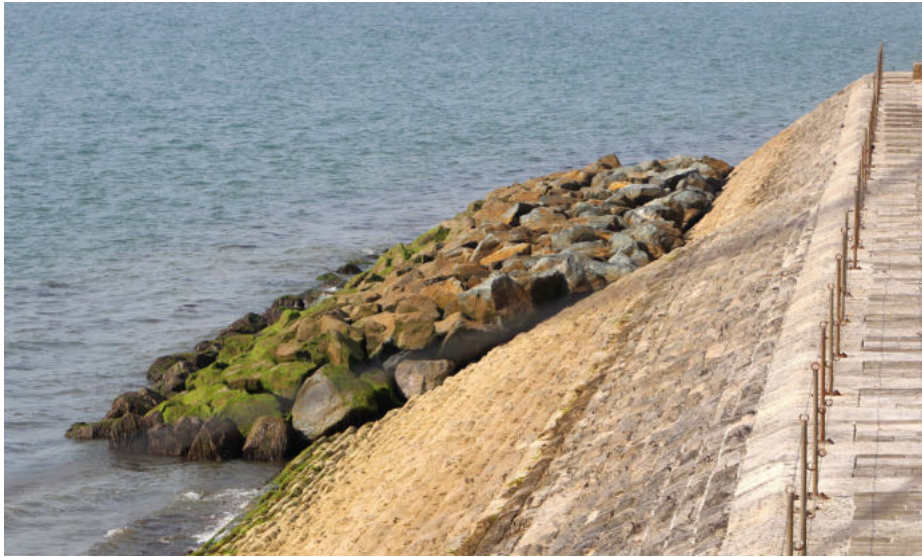
Figure 39 Aug 2020. The emergency repair at the SW end of the moat wall. CHD.

The temporary emergency repair to the SW end of the moat has been completed to a very high standard. For this repair, heavier and larger rock has been used [a total of 1,500 tons] and efforts made to ‘seal’ the work in place to avoid the failure of the 2014 work. This will certainly buy time.

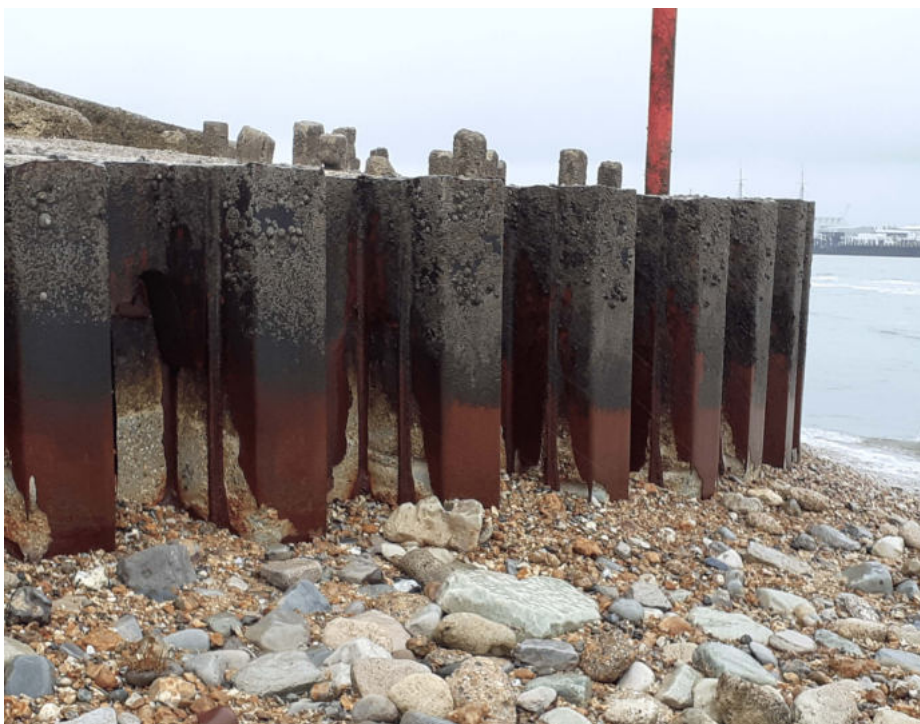
Figure 40 2020. The harbour entrance piles, looking North. The steel is shot and the concrete backing, seen through the piles, does not look in good shape. AM.

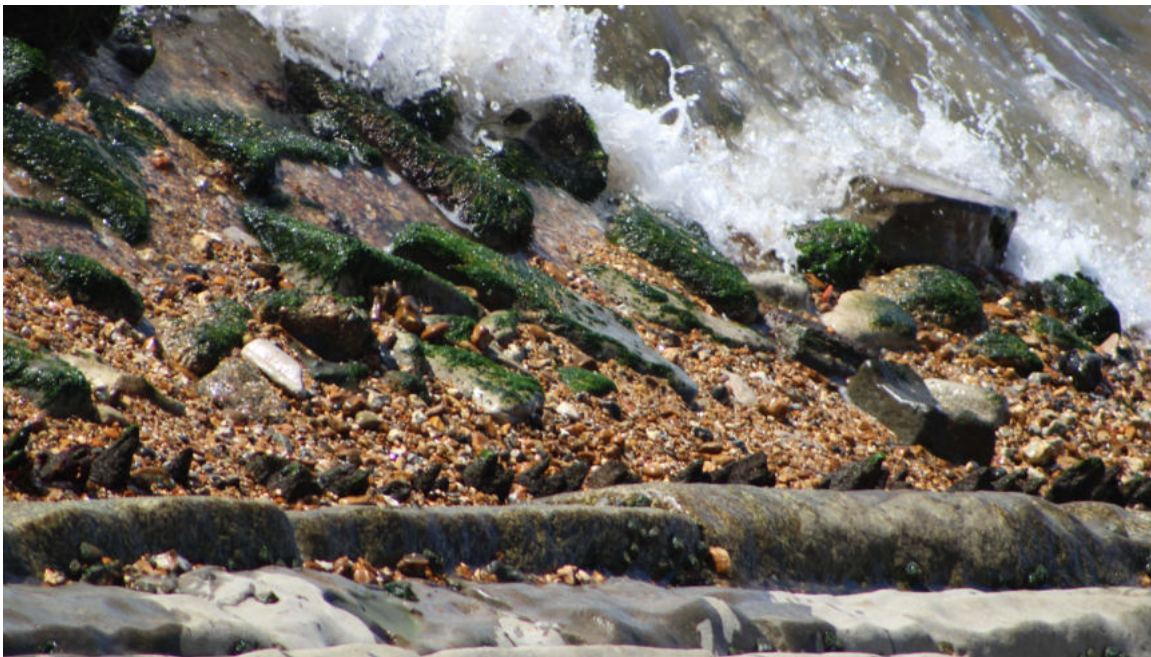
Figure 42 2019. Looking down from the top of the wall, close to the harbour entrance. For the first time in living memory, the remains of the piles, used when forming this part of the wall, are exposed. CHD.

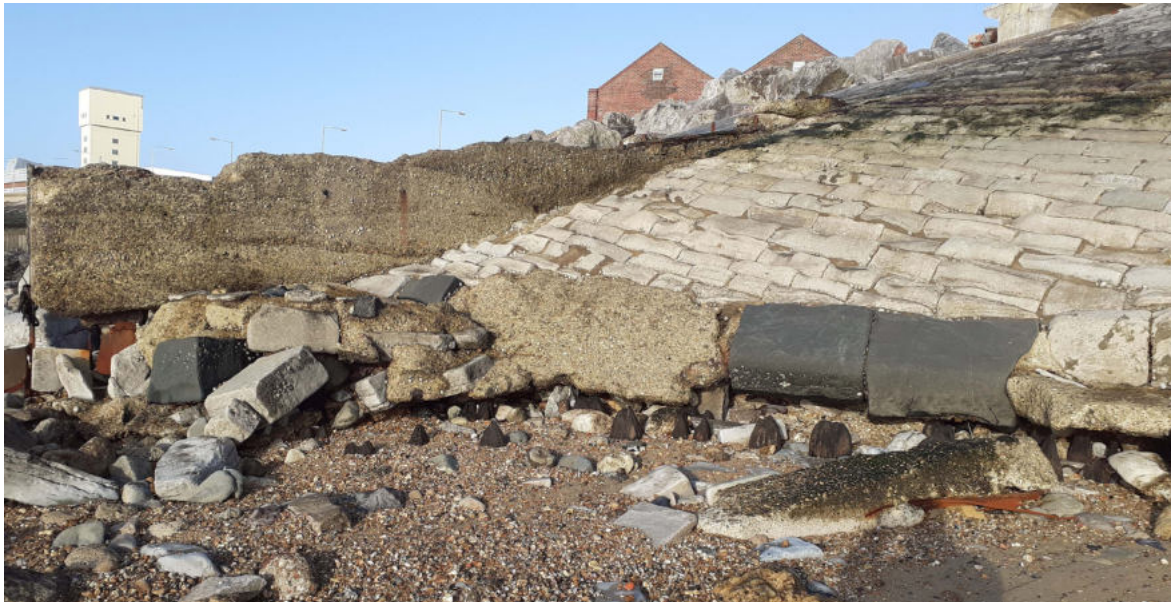
Figure 43 2020. A graphic illustration of the undermining process. Once the water gets under the existing defences, the only ‘resistance’ here is sand and shingle. AM.

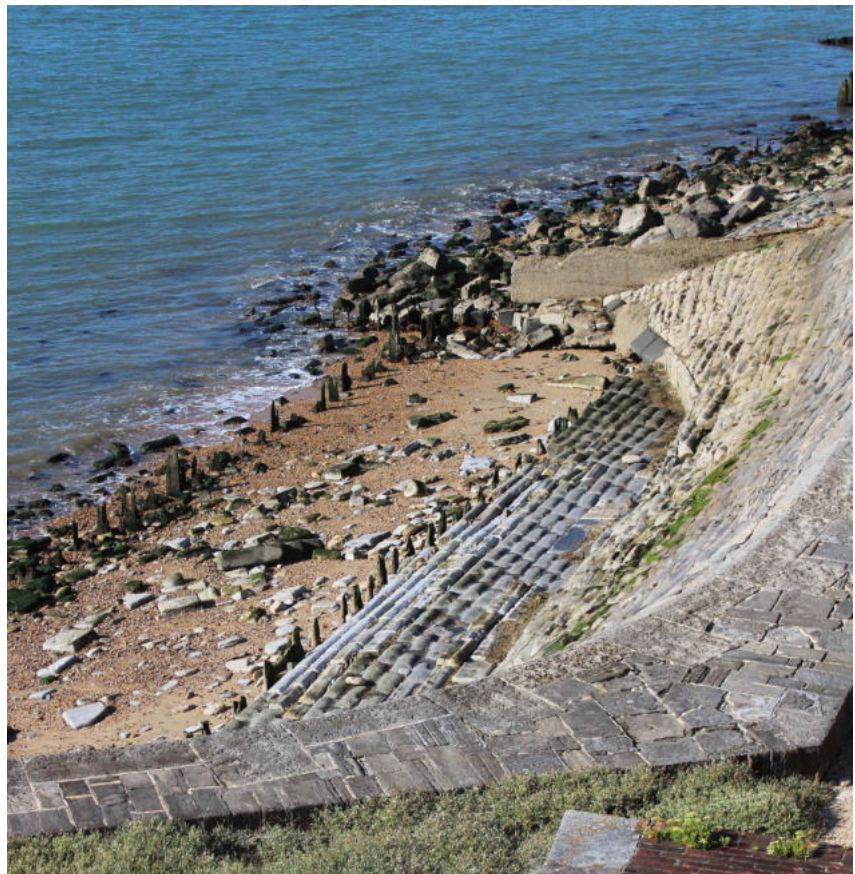
The pavement (centre, fig. 45), exposed c.2015 for the first time in many decades, probably represents a Victorian repair. The shoreline has eroded significantly. And then compare with fig.46 below.

Figure 45 August 2019. The same position as above. The 1900s piles are almost gone. CHD.

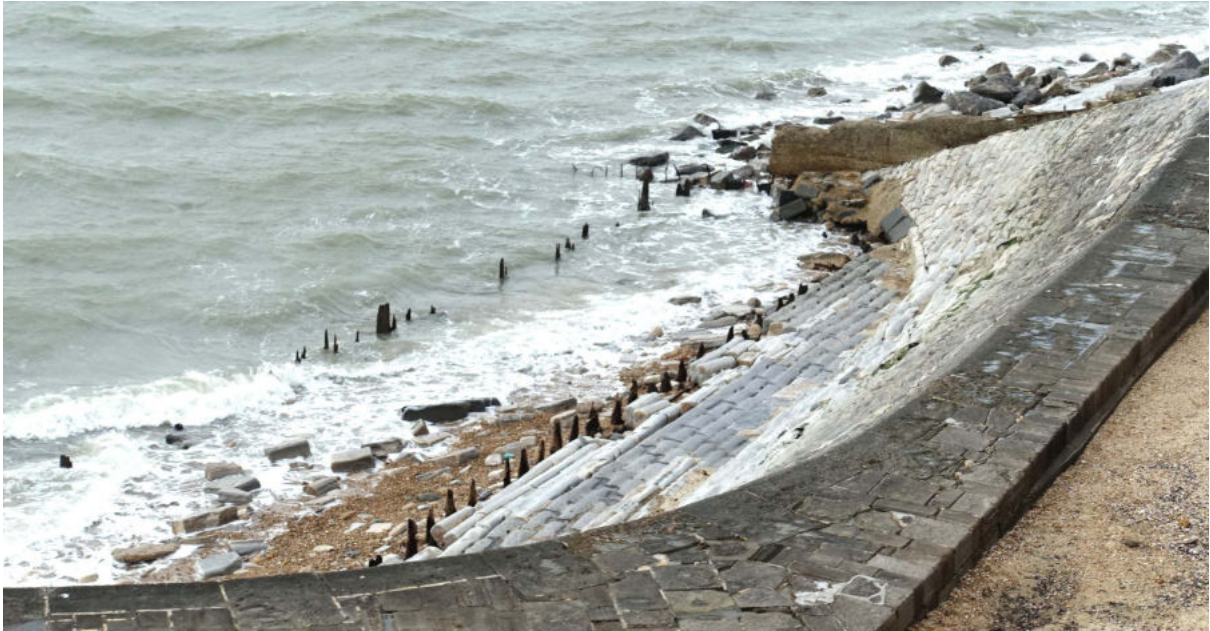
Figure 46 Feb 2020. Post Storm ‘Dennis’. The shoreline was still receding and the platform [centre] was coming apart; CHD.

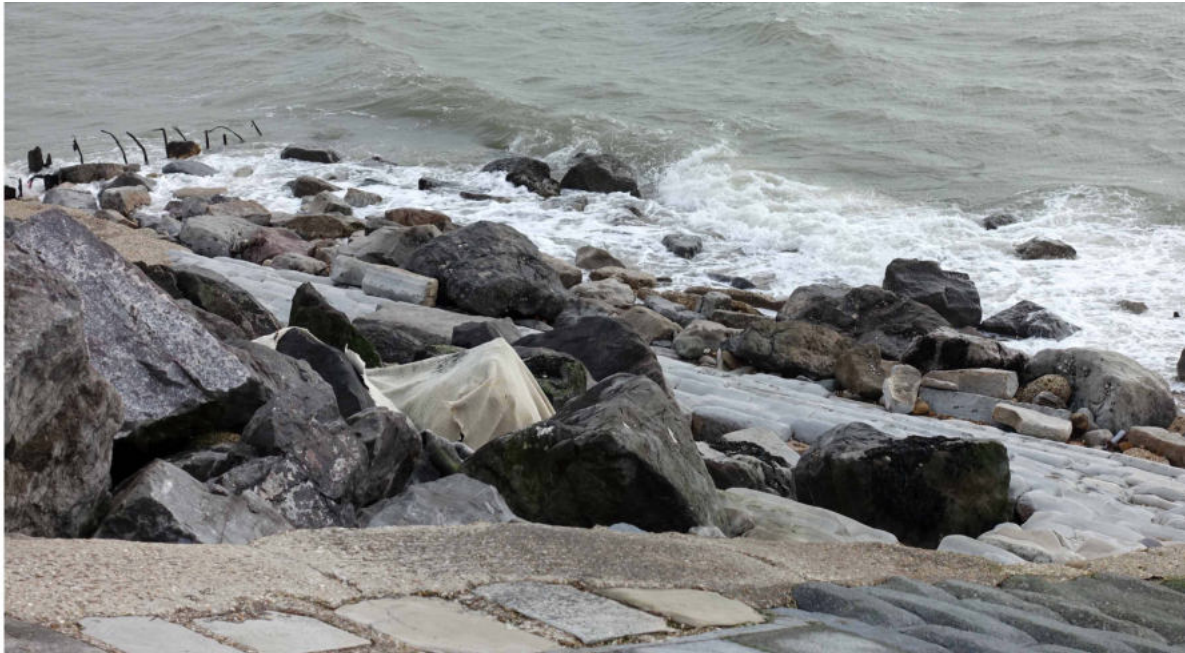
Figure 47 Feb 2020. The 2014 ‘temporary emergency repair’ after Storm Dennis; note how the rock armour has been tossed around like marbles; the repair was failing; CHD.

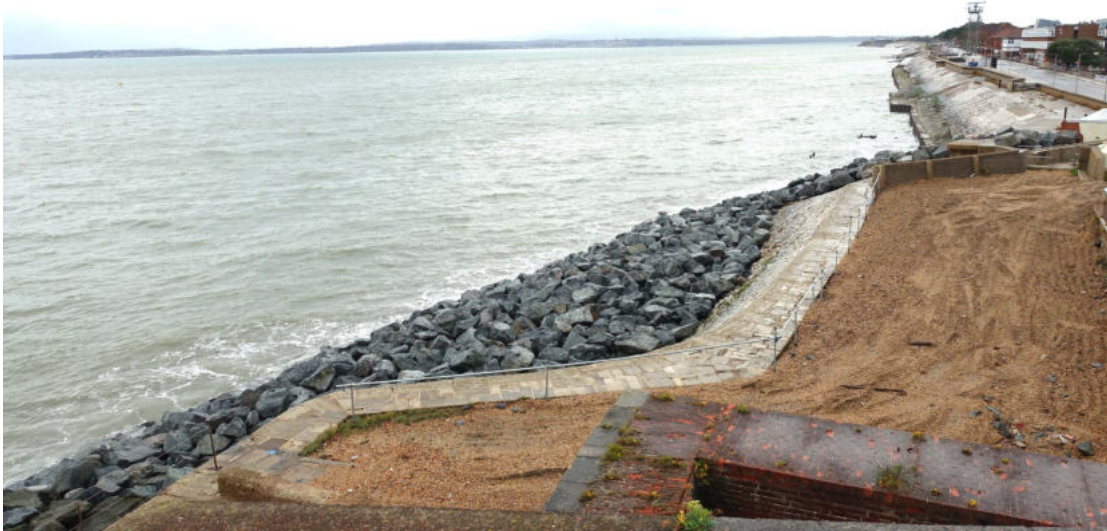
Figure 48 Oct 2020. The new temporary repair extending from the recently completed moat work [bottom left] - see fig. 39. CHD.

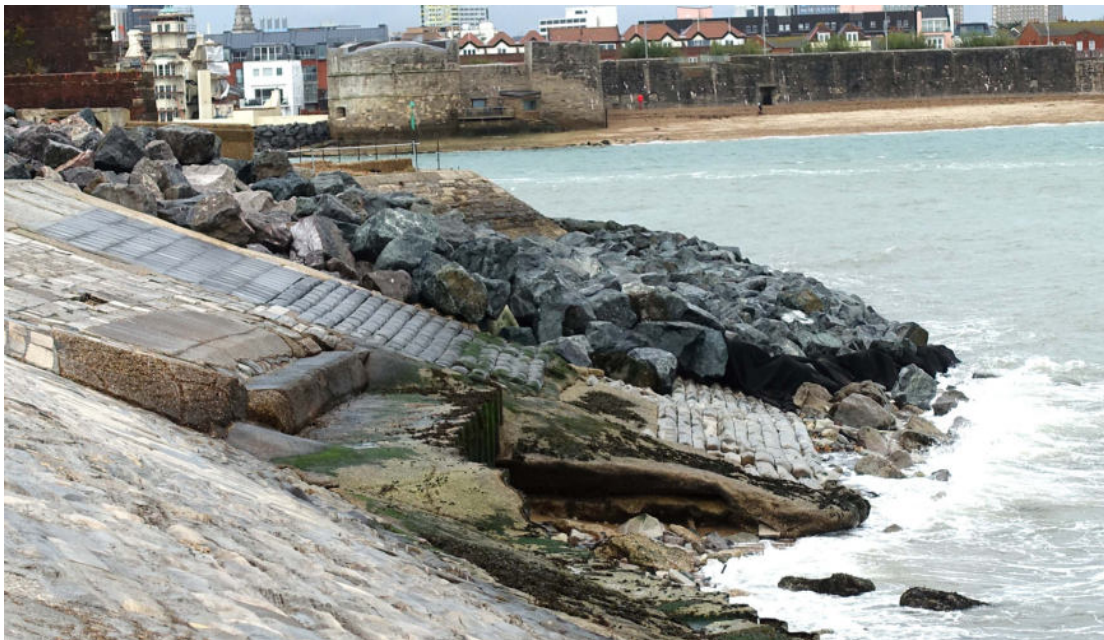
Figure 49 The repair stops short of the sheet piling, apparently due to some issue with the MMO licence extension. CHD.

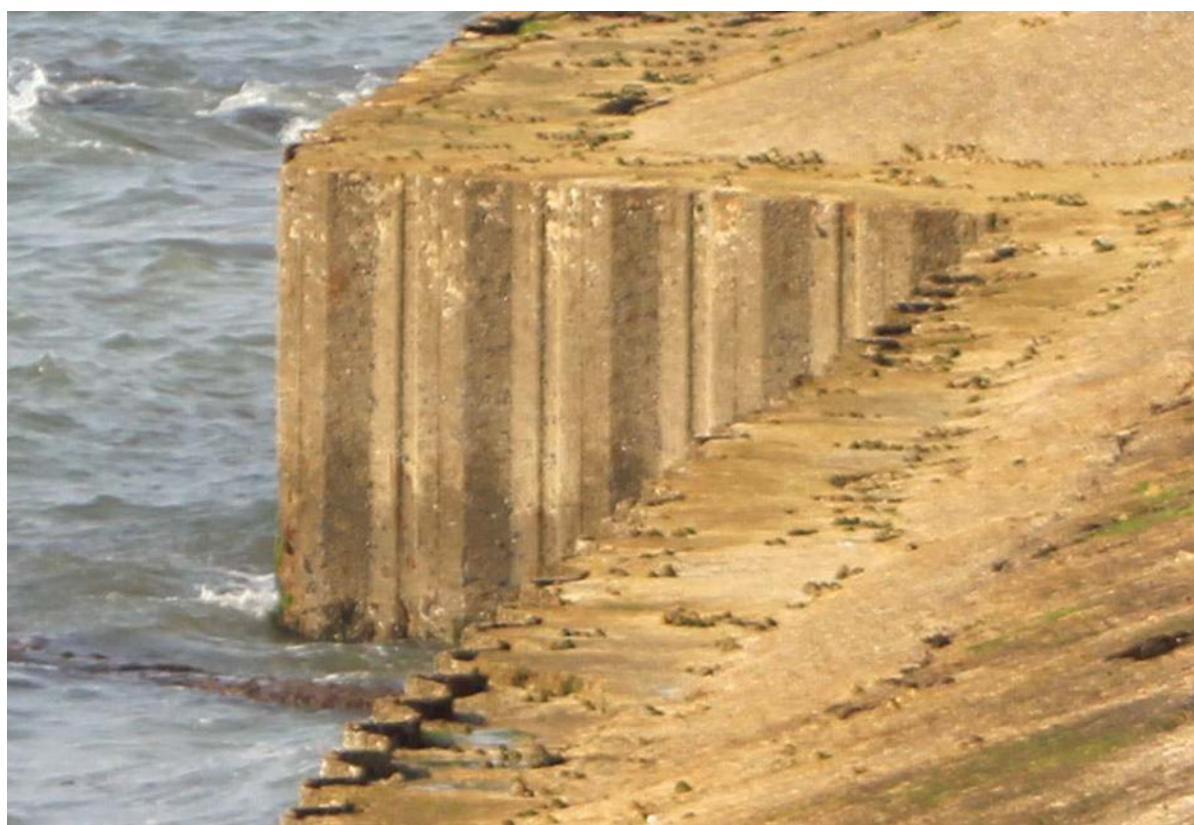
Figure 50 Aug 2020. Piles, last noted in place in photograph dated 2014, are now missing completely. Piles and concrete backing are parting company in the foreground. CHD.

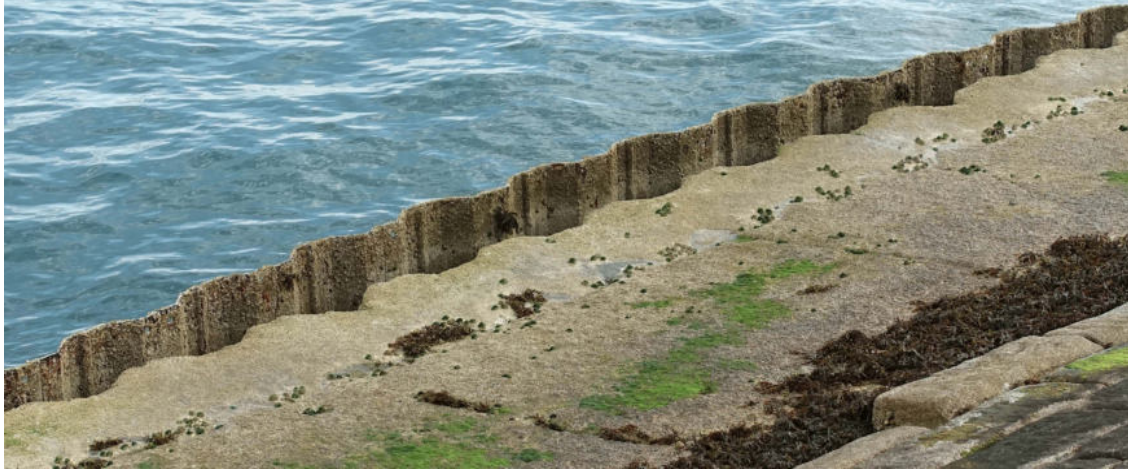
Figure 51 Aug 2020 Pile damage opposite the old submarine school. CHD.
