The Threat to Portsmouth Harbour

Christopher Donnithorne

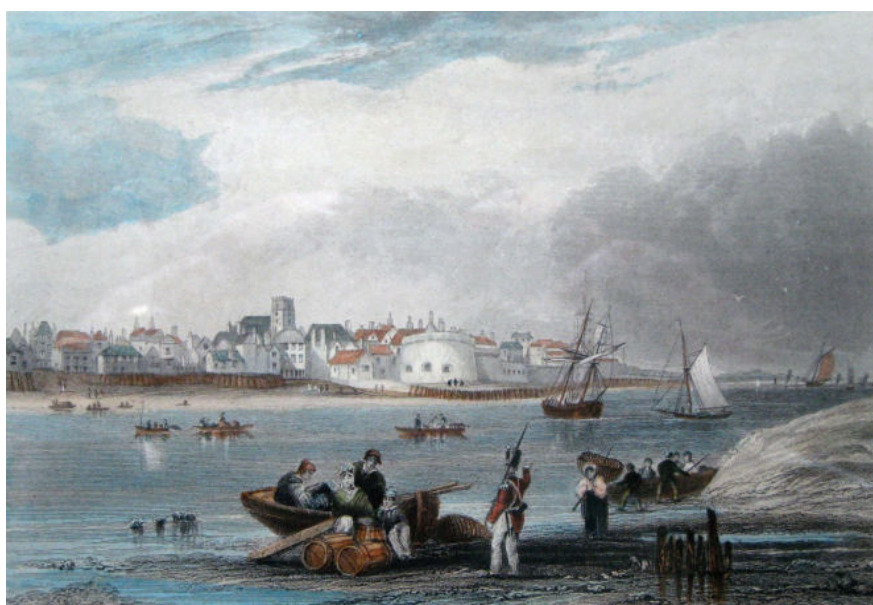
Figure 5 Blockhouse Point in 1830s, looking across to Portsmouth. The beach is obviously depleted.

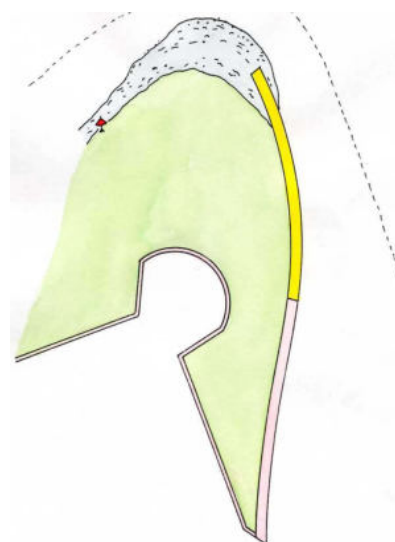
‘I find that a portion of the Bank of Shingle extending to about 150 feet in length and 4 feet in depth has been recently washed away during the late heavy gales, commencing from the termination of the Breakwater lately completed by the Department and extending towards the Harbour...’¹⁴

The Commanding Royal Engineer protested that no shingle had been removed by his department, that the estimated cost for the new [see yellow wall in fig. 6] would be £950 and then went on to suggest that ‘it does not appear to be an Ordnance question but one connected with the preservation of the Harbour’ [and therefore a charge to the Admiralty]¹⁵.

Figure 6 1848. The pink coloured wall represents the breakwater ‘lately constructed’ and yellow - that now proposed. The top of both can still be seen today. Sketch adapted from WO 44/284. CHD.

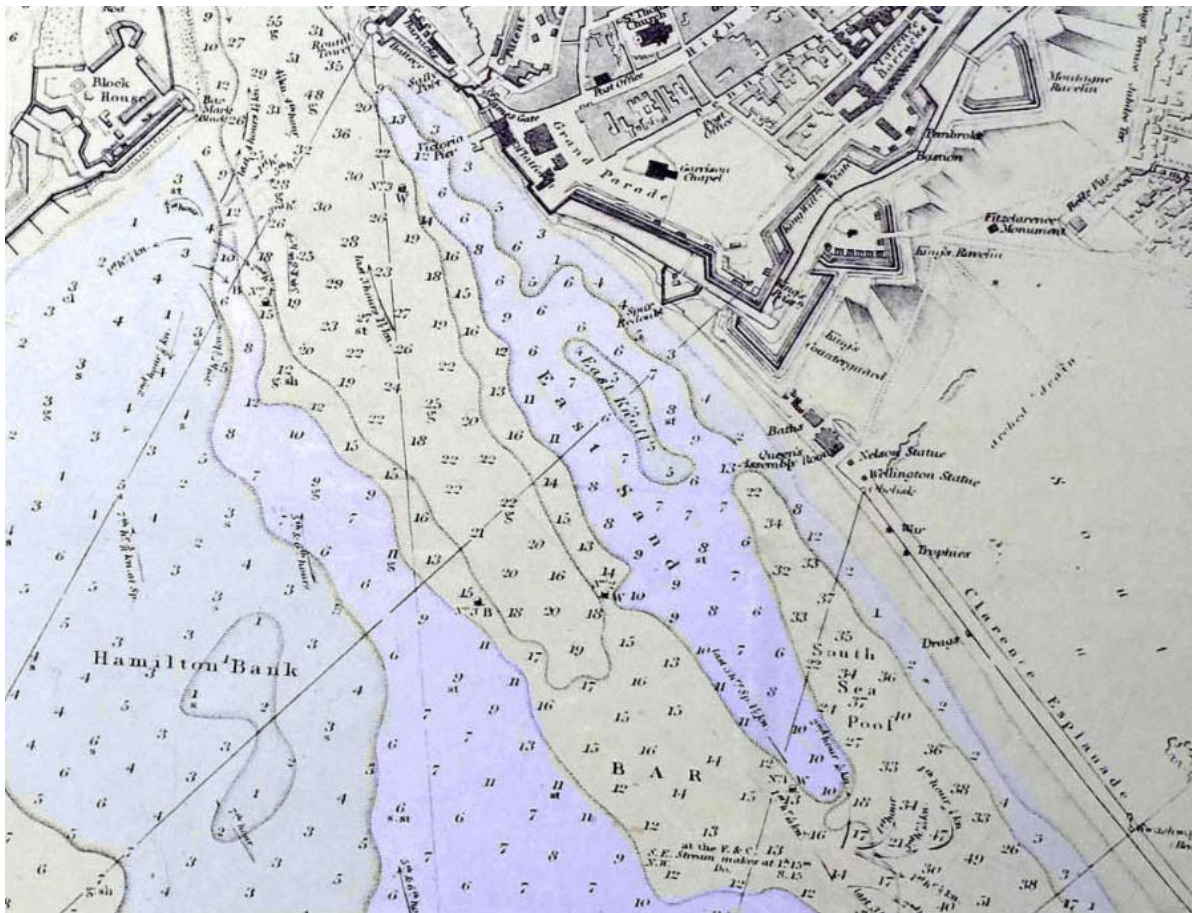
The shallowest part of the main channel shown in fig.14 is 12 feet. In 1844, the local pilot noted 'there is on the bar at low water ordinary spring-tides, namely 12.5 feet', remarkable stability in over a hundred years. This was imposing a serious constraint on use of the harbour - see fig. 15 below.

Figure 15 1858. Channel still constrained by the 'Bar' - see bottom centre of the image. Note Hamilton Bank has a mean depth of 3 to 4 feet; based on Admiralty Chart 2631, detail.

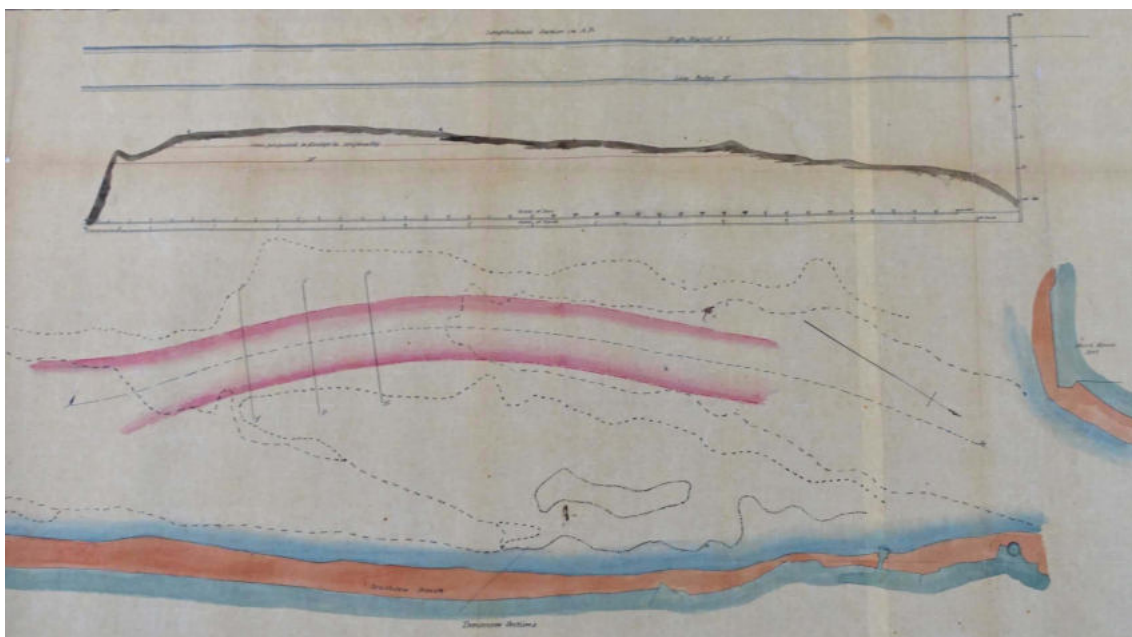
Figure 16 c.1860. Proposed dredge of the bar in the approach channel to Portsmouth, to about 25 feet below LWOST. Blockhouse Fort is to the extreme right.; TNA, MRQ 1/33.

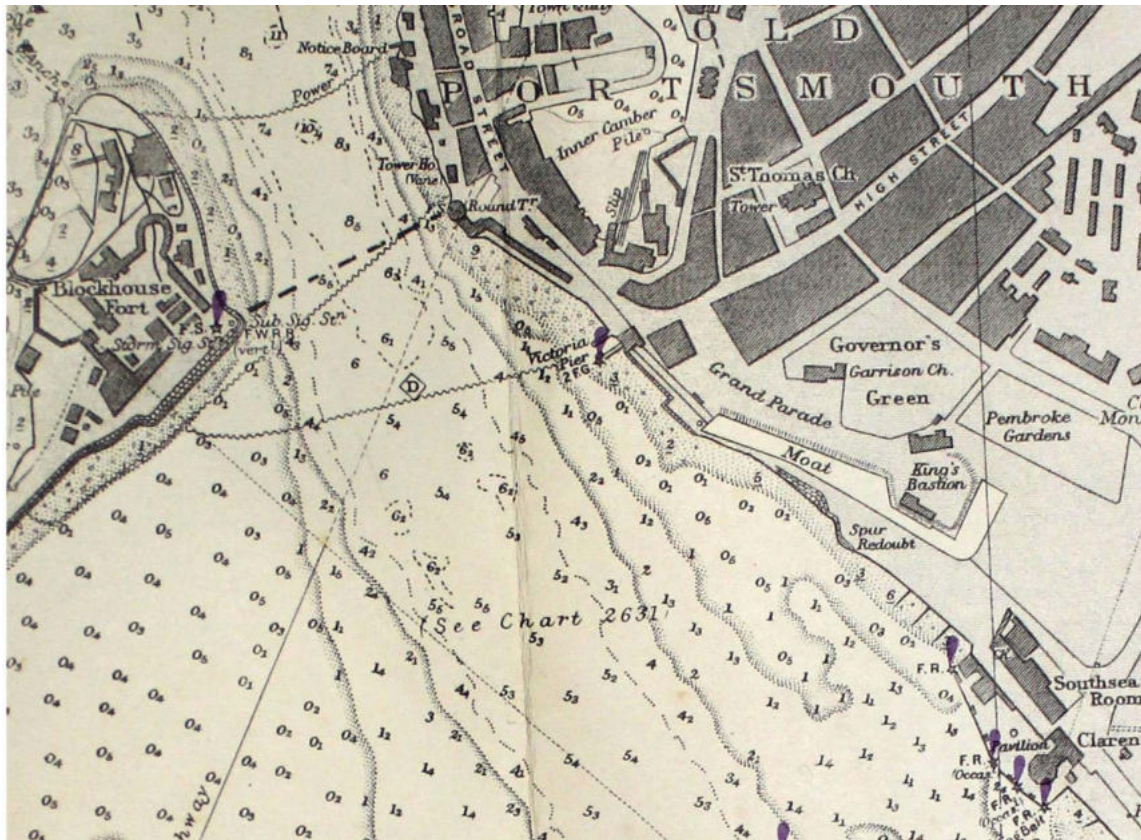
Figure 17 1942. Compare with fig 15 and note the depth over Hamilton Bank. Although the depth of the channel has been significantly increased, stability has been maintained; Admiralty Chart 2625, detail.

Dredging might have doubled the depth of the main channel in a century but the profile of Hamilton Bank has been maintained and the beach at Blockhouse seawall is largely unaffected by the changes.

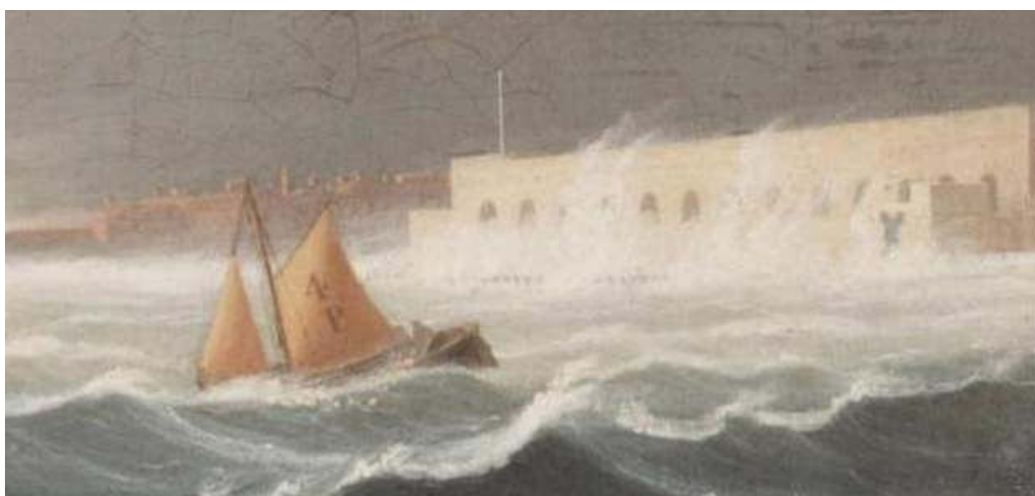
Figure 18 c1820. A pilot boat beats out of harbour. Haslar is in the background and harbour entrance to the right. The fort is really exposed. MoD.

The fact is costly repairs have always been necessary. Today the fort is just as vulnerable to gales from the South.

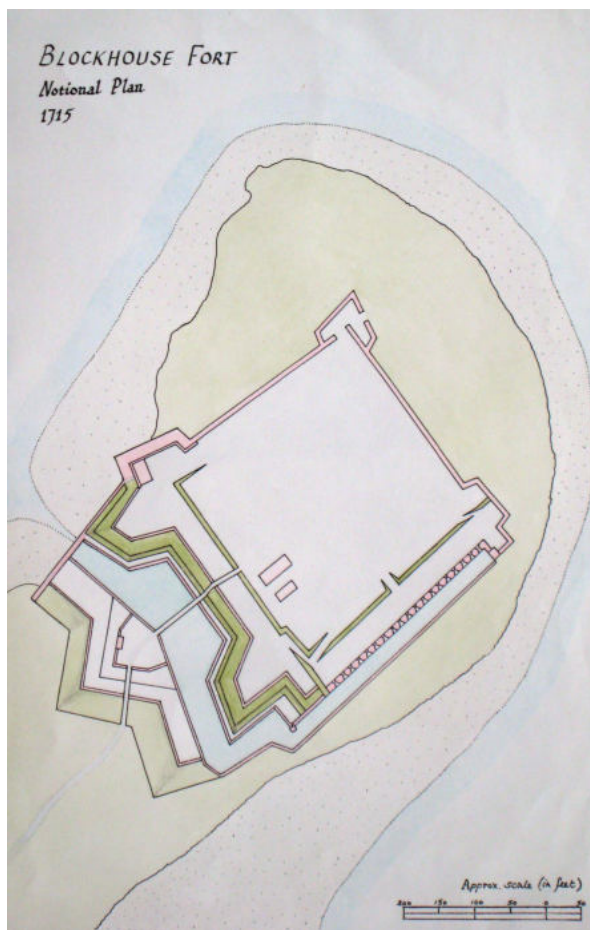
Figure 20 1715; the fort as rebuilt during Queen Anne's time. Of particular interest here, the outer wall at the bottom of the plan approximates to the position of the 2013 damage; a notional plan adapted from some two dozen partial or low quality images, viewed at multiple places. CHD.

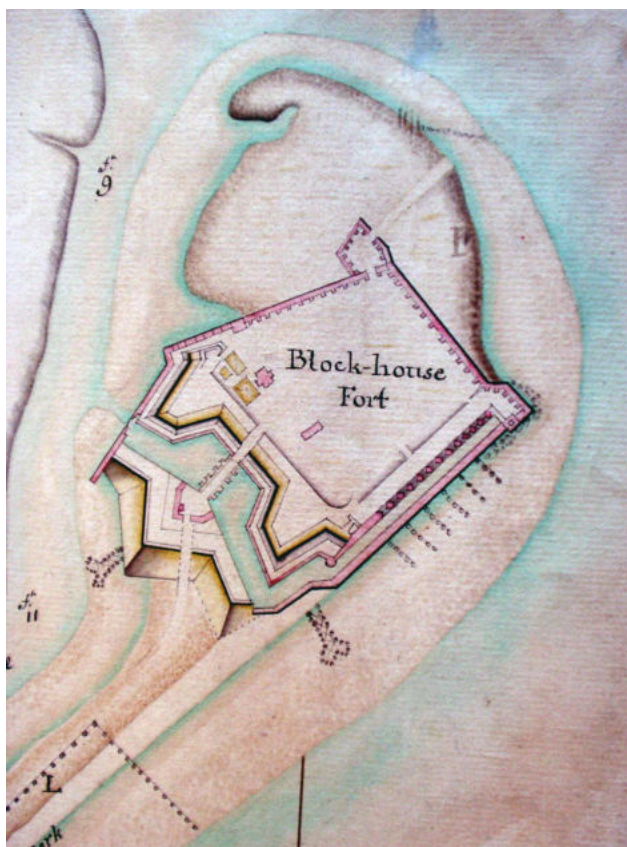
Figure 21 c1756. 'L' at the bottom left refers to an earlier repair, 'Wharf and Grind, built in the Year 1746, to stop a Breach made by the Sea, which endangered the Entrance of Portsmouth-Harbour.' Note centre right, where the beach is receding, as tidal eddies cause erosion, requiring extensive piling; MoD, Admiralty Library, Pfo B/31, detail.

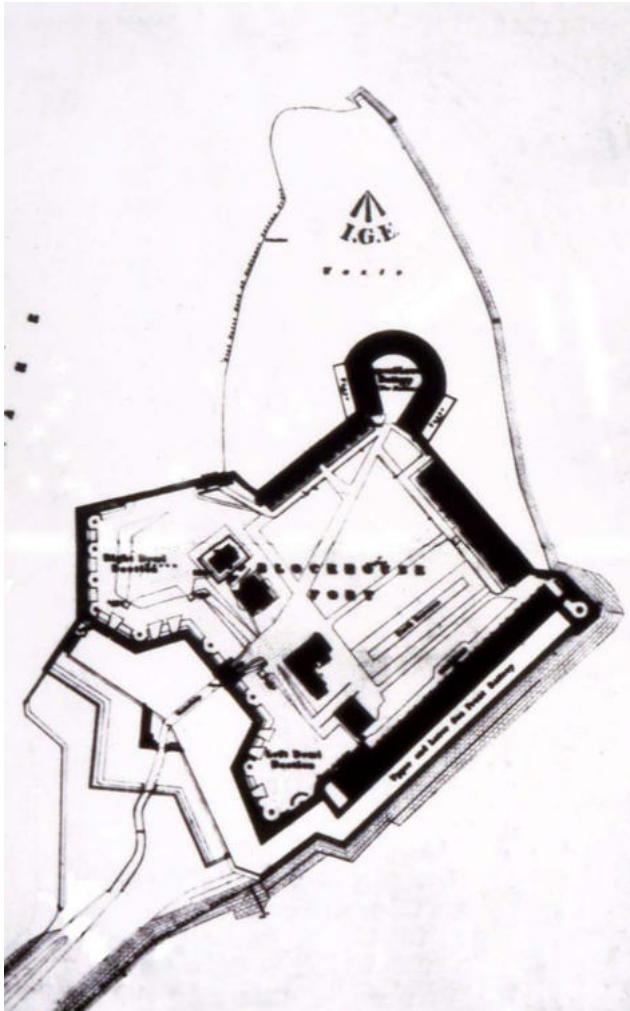
Figure 22 1840s rebuild. This dates the wall in front of the main battery. The wall from there to the bottom left is from an earlier age. MoD.

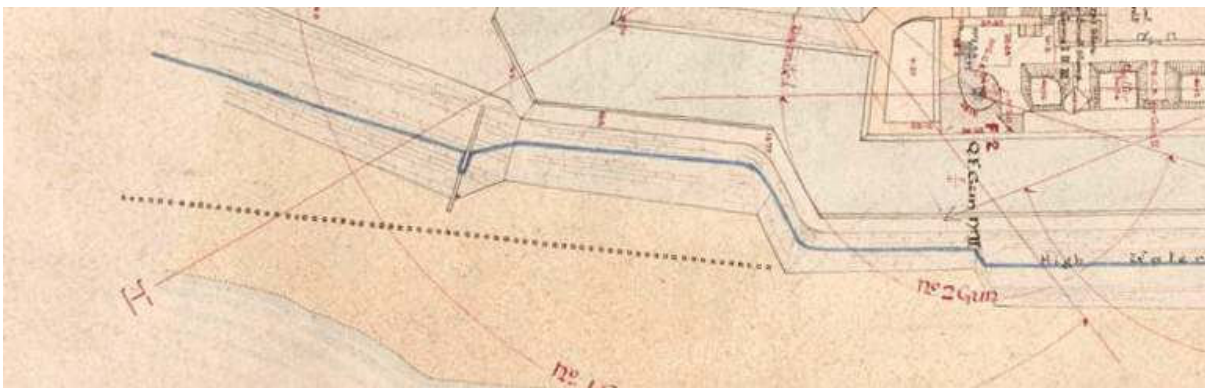
Figure 23 1890s. The remains of this line of piles [the dotted horizontal line] are still visible; TNA, WO 78/5028/003/1, detail.

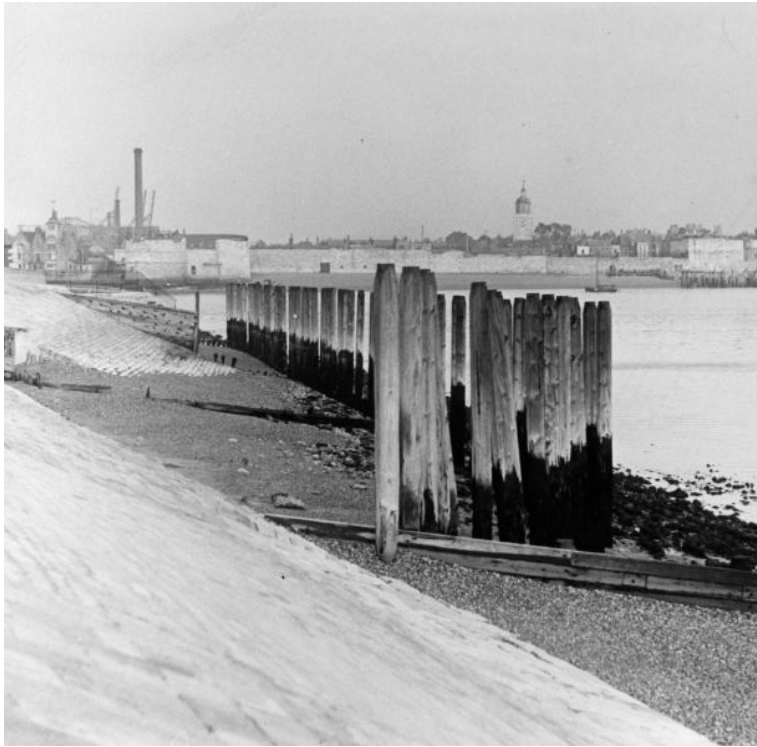
Fig. 24 shows the piles still in place and able to fulfill their original function - to disperse the full strength of the waves on this vulnerable part of the wall. Perhaps because they deteriorated relatively rapidly, or some Senior Officer thought they looked 'untidy' - whatever, they were cut off at shore level in the 1930s.

Figure 24 1928. Piles still in place. MoD.

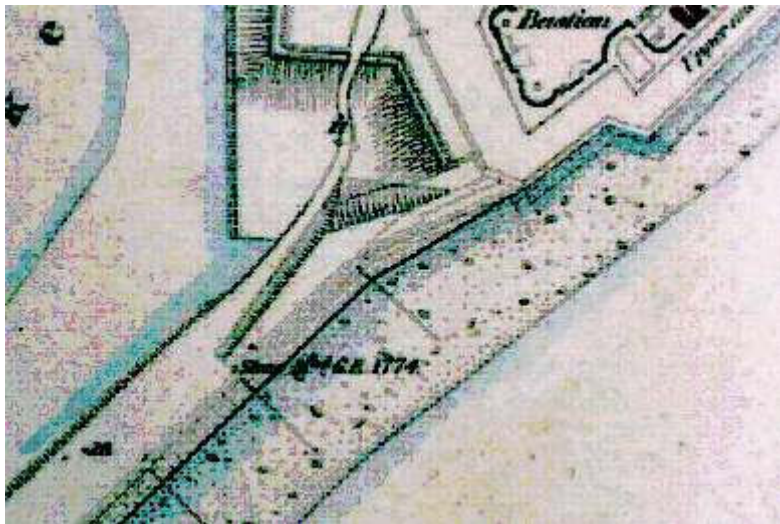
Fig 26 Portsmouth, as a natural deep water harbour, is well protected from all but southerly gales. It is relatively rare south-easterly gales which, in combination with a high tide, cause the lowest parts of the fort to flood and renders the causeway impassable. This section, at the western end of the Queen Anne fortifications has been rather crudely incorporated into the moat wall, leaving a small indentation which remains vulnerable to the present day. The wall itself is exposed to every southerly gale, the more so as the beach level recedes [source unidentified].

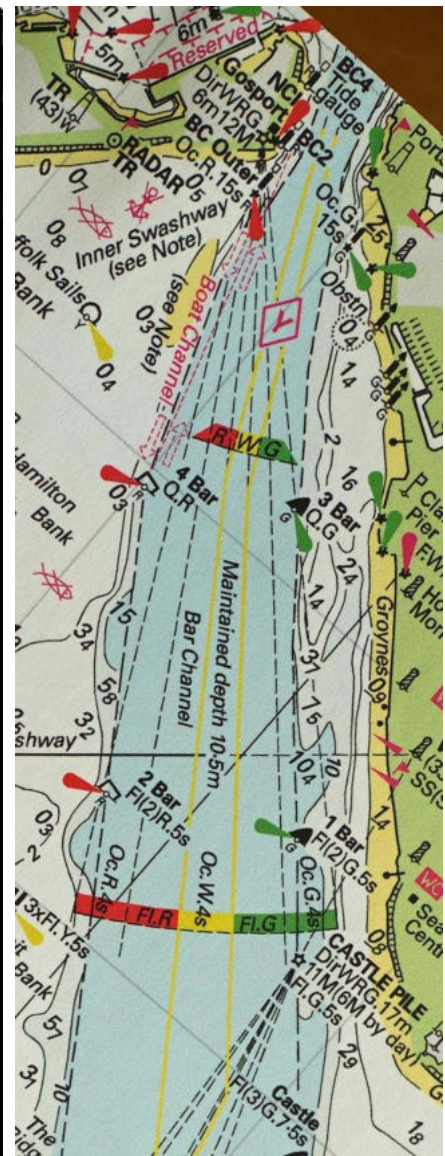
Figure 35 Post QE dredge; © Imray Laurie Norie and Wilson Ltd.

Compared with the Admiralty chart for 1974 [latest pre-dredge to hand], the post-dredge chart demonstrates inroads made into the Hamilton Bank with a wider channel than ever before, the bank being taken in places from less than 3 to 11 metres.³⁶ A relatively stable environment has been transformed, and the almost immediate impact of this work on Blockhouse Wall seems entirely predictable, and indeed had been predicted. This questions the thoroughness of the pre-dredge Environmental Impact Assessment.

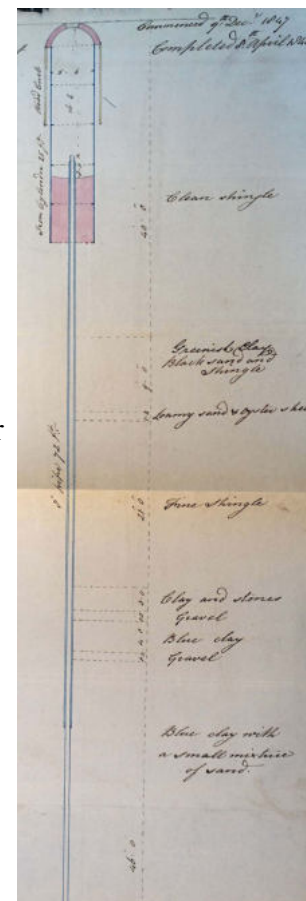
A core sample indicates that the Fort is sitting on a bank of sand and shingle, some 24 metres thick, below which clay starts to appear. The seashore, now at foundation level, is lower now than in living memory. Once started, erosion of the exposed sand and shingle would be expected to be rapid. The threat is obvious and, without the scour, major silting of the harbour itself is inevitable.

Figure 38 1847. Top of well core from centre of the Fort. TNA, WO 44/283.

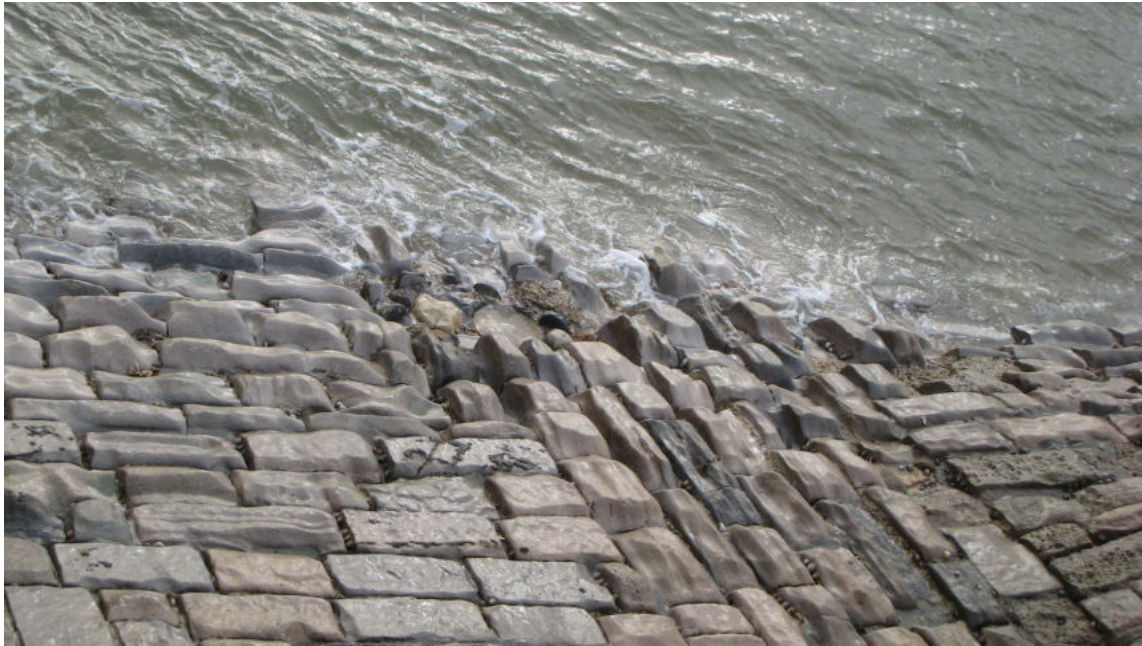
Figure 41 2014. Looking down from the top of the wall, close to the harbour entrance. CHD.

It is noticeable that stone has been ‘washed along the extremity of the wall - old stone facings and some rock armour from the failing 2014 emergency repair. Undoubtedly some stone is already dropping into the channel at the harbour entrance. Learning from the experience, the new ‘moat’ repair has used rather heavier rock armour and has attempted to stabilize the rocks.

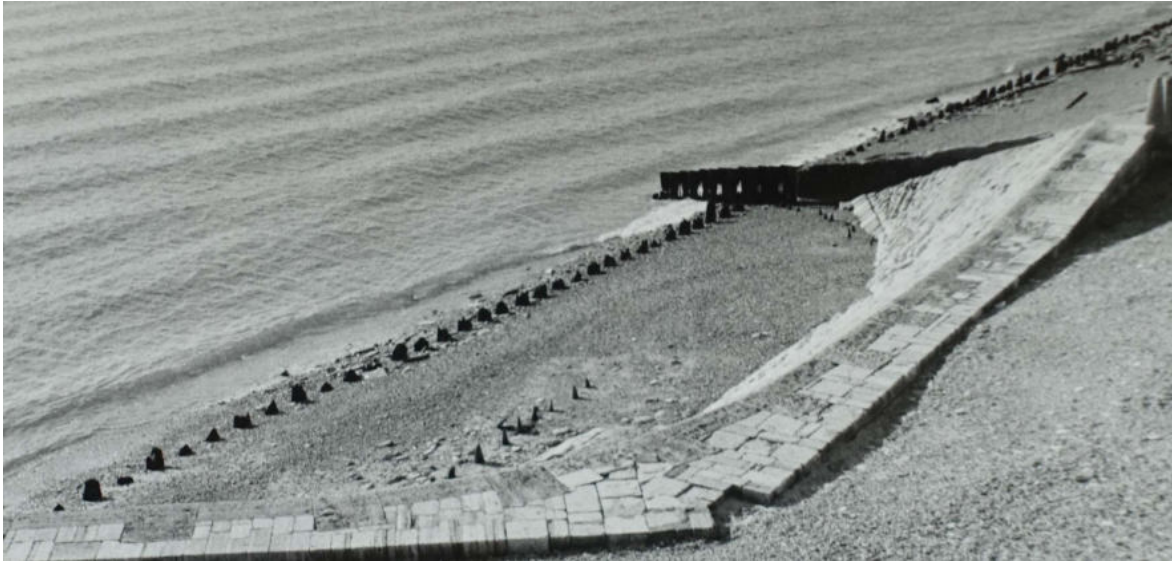
Moving back to the older part of the seawall, it will therefore come as no surprise that, post the carrier dredge, the seawall [as opposed to Moat Wall] at Blockhouse is being undermined as well. By way of illustration compare photographs taken in 1987 with another taken in August 2019.

Figure 44 The foreshore in 1987. The remains of the 1900s piles are at the water's edge. MoD.

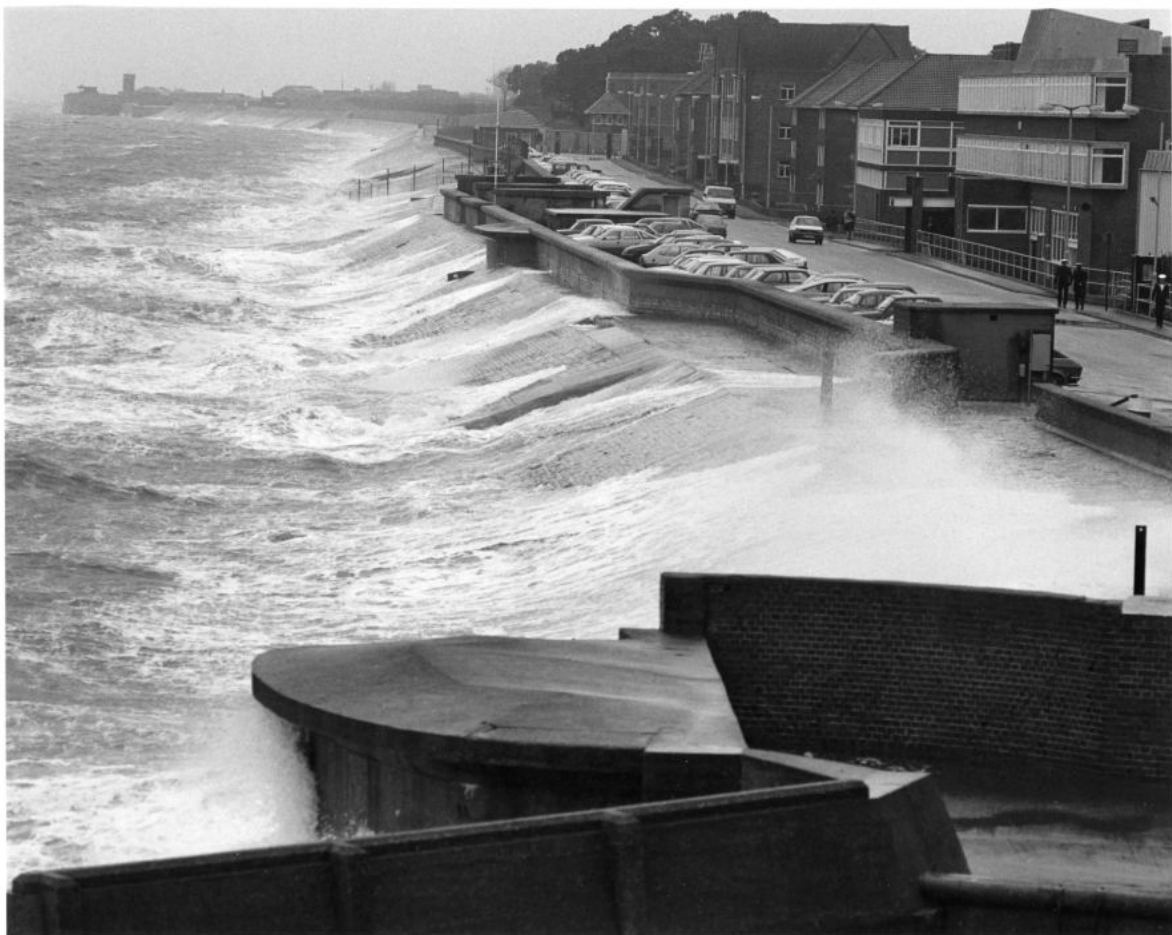
Figure 52 1987. The scene during a moderate gale, looking from the Fort towards Haslar. Potential building site to the right. In a storm, the wall takes a terrible battering. A description of one such event reads, 'large volumes of seawater pass over the sea wall carrying with it quantities of shingle and large concrete slabs. The road became impassable ...'. As noted earlier, the large concrete structure in the foreground was carried away in Dec 2013. The subsequent temporary emergency work, never replaced with a permanent repair, was itself badly damaged by Storm Dennis in Feb 2020. MoD.
